SCREENING SITE INSPECTION REPORT  
FOR  
BEMIS COMPANY, INC.  
PEORIA, ILLINOIS  
U.S. EPA ID: ILD006215727  
SS ID: NONE  
TDD: F05-8812-011  
PAN: FIL0585SA

AUGUST 3, 1990

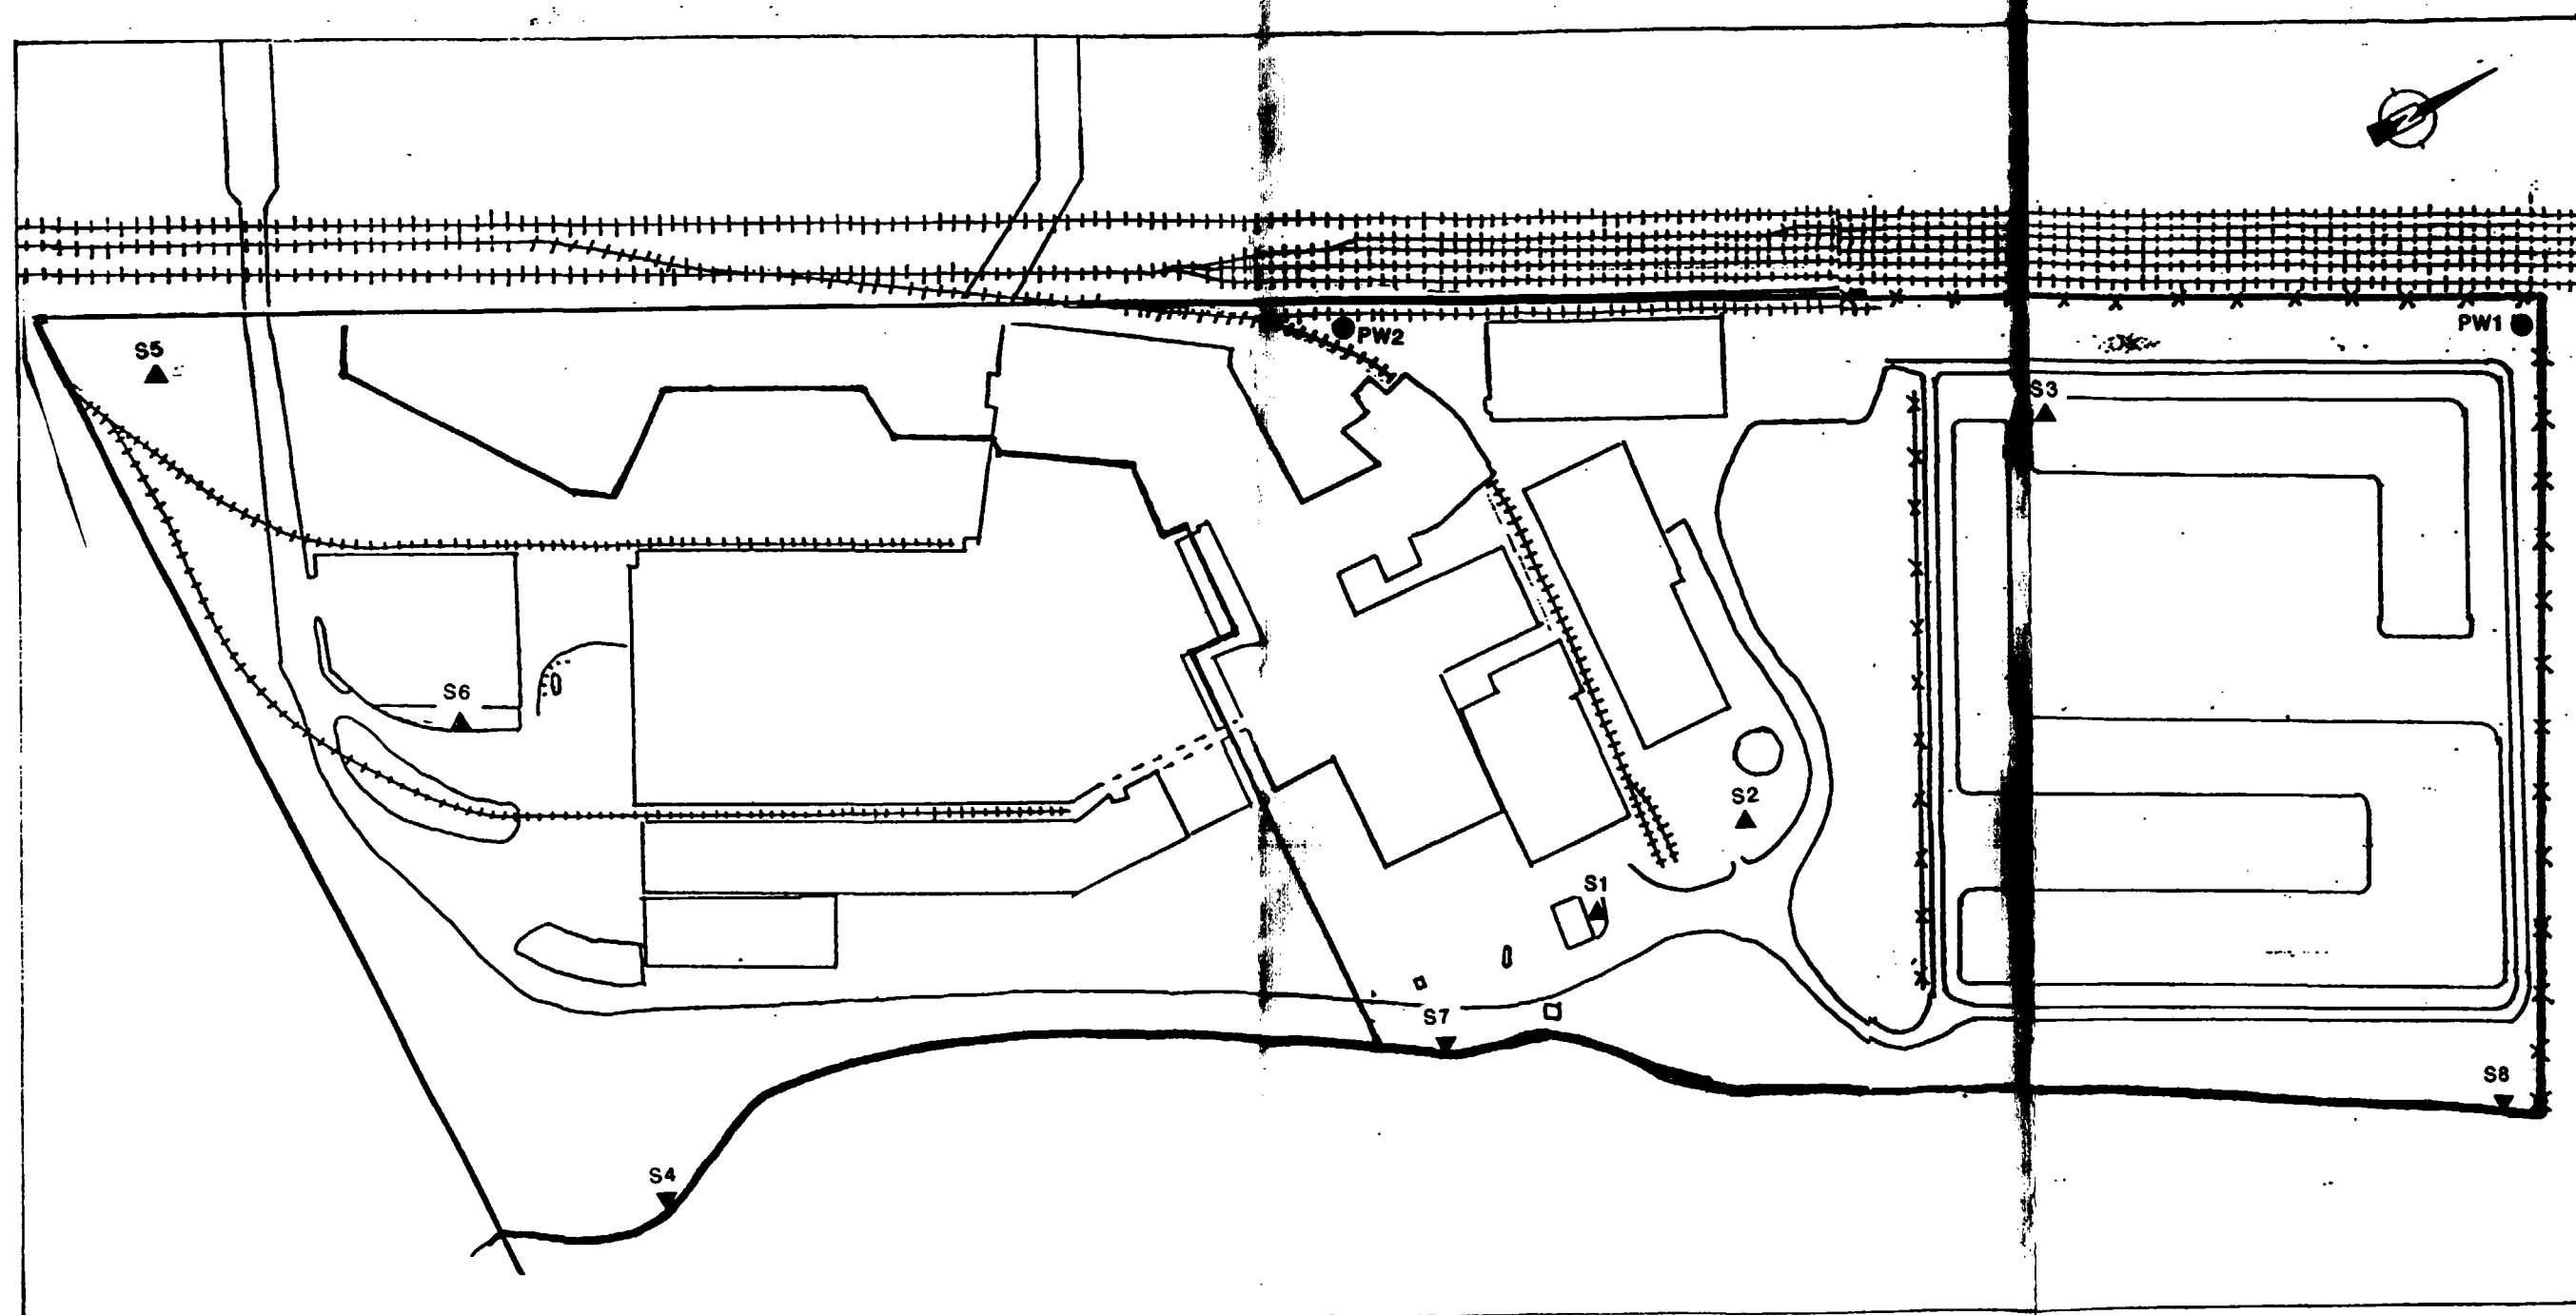
Soil/Sediment Sampling Procedures. Surface soil sample S1 was collected from the gully behind a garage with one open side in an area of possible drainage (see Figure 3-2 for soil/sediment sampling locations). Surface soil sample S2 was collected from the gully near the oil tank in an area of possible drainage. Surface soil sample S3 was collected from near the pool of water next to the fly ash pile.

Sediment sample S4 was collected from the shore of the Illinois River near the southern (downstream) boundary of the site. Surface soil sample S5 was collected from the grassy area south of the entrance to Bemis Company as a potential background soil sample. The background soil sample was collected to determine the representative chemical content of the soil in the area surrounding the site. This location was chosen because the ground surface appeared to be undisturbed. Surface soil sample S6 was collected from the stained grassy area near the barrels on the Bemis Company property. Sediment sample S7 was collected from the shore of the Illinois River where water was observed draining from an underground pipe. Sediment sample S8 was collected near the northern property boundary of the site as a potential background sediment sample.

SOURCE: Ecology and Environment, Inc., 1990.

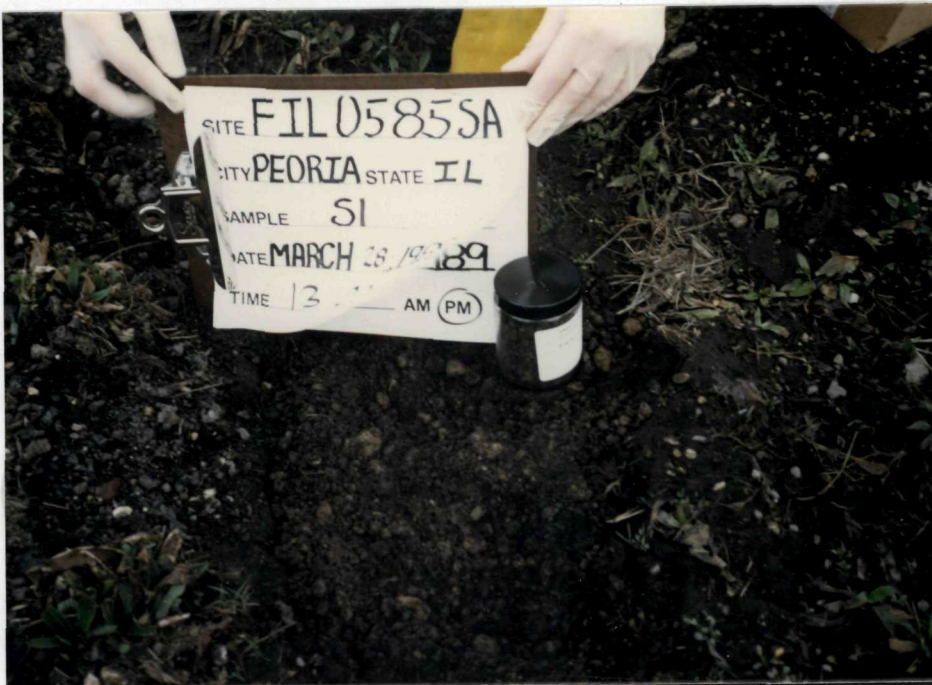
SITE NAME: BEMIS COMPANY, INC.PAGE 1 OF 18U.S. EPA ID: ILD006215727 TDD: F05-8812-011PAN: FIL0585SADATE: 3-28-89TIME: 13:00DIRECTION OF  
PHOTOGRAPH:  
EAST-NEWEATHER  
CONDITIONS:  
PARTLY CLOUDY~ 70°FPHOTOGRAPHED BY:  
D. SULLIVANSAMPLE ID  
(if applicable):  
SIDESCRIPTION: CLOSE - UP OF SOIL SAMPLE SI.

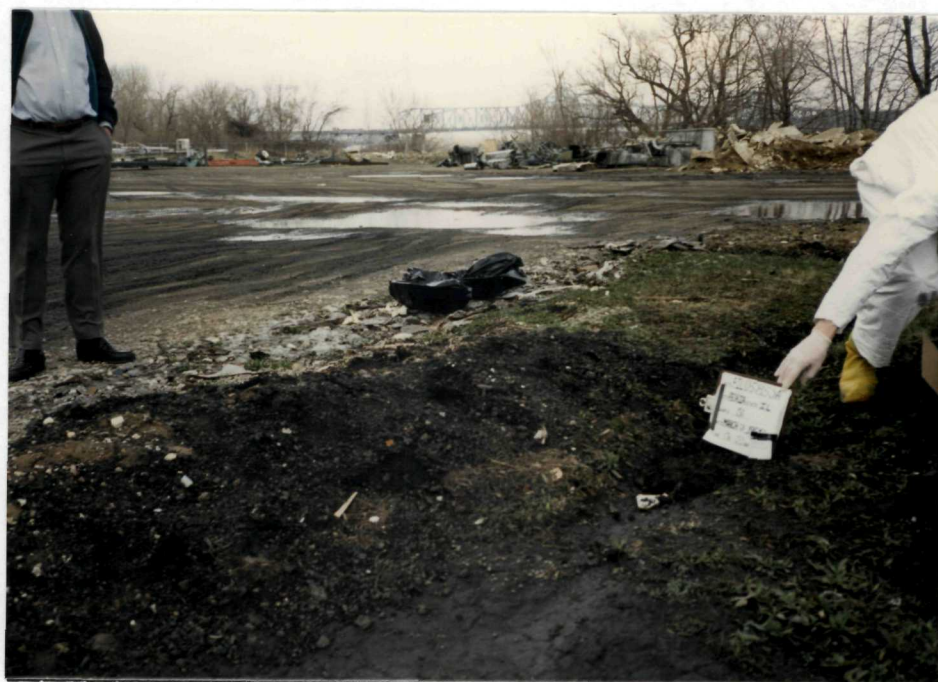
DATE: 3-28-89TIME: 13:00DIRECTION OF  
PHOTOGRAPH:  
NEWEATHER  
CONDITIONS:  
PARTLY CLOUDY~ 70°FPHOTOGRAPHED BY:  
D. SULLIVANSAMPLE ID  
(if applicable):  
SIDESCRIPTION: PERSPECTIVE OF SOIL SAMPLE SI.

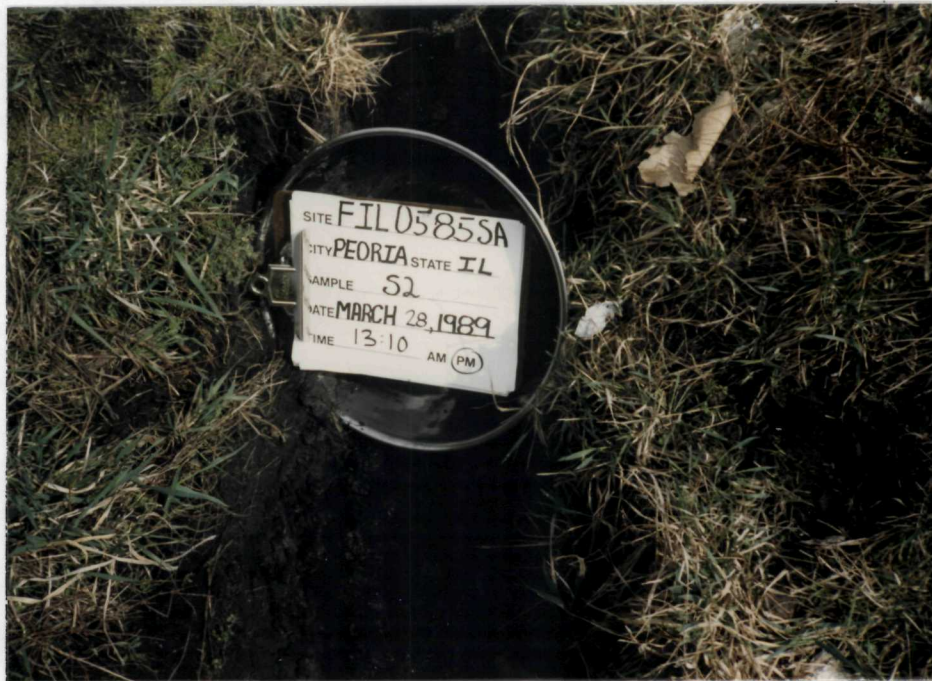
DESCRIPTION: CLOSE-UP OF SOIL SAMPLE S2.DATE: 3-28-89TIME: 13:10DIRECTION OF  
PHOTOGRAPH:  
EAST-SEWEATHER  
CONDITIONS:  
PARTLY SUNNY~ 70°FPHOTOGRAPHED BY:  
D. SULLIVANSAMPLE ID  
(if applicable):  
S2

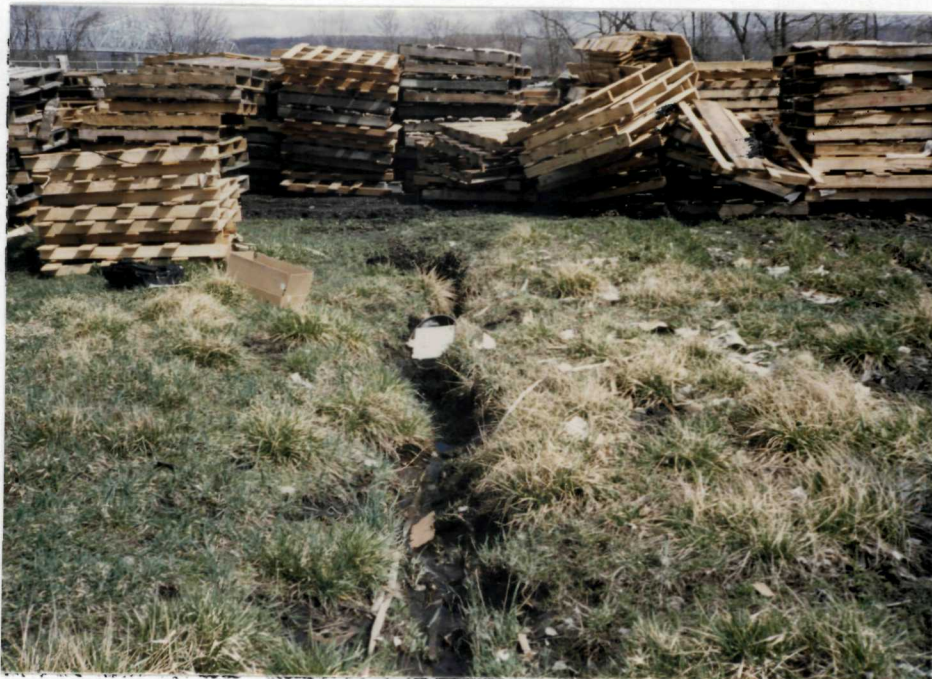
DESCRIPTION: PERSPECTIVE OF SOIL SAMPLE S2.

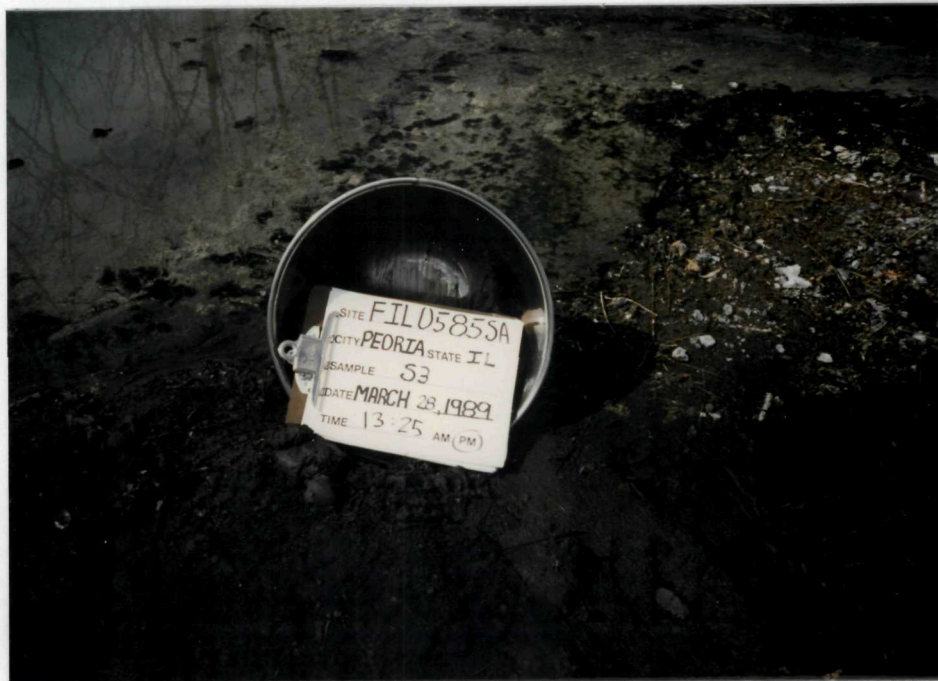
DESCRIPTION: CLOSE-UP OF SOIL SAMPLE S3.DATE: 3-28-89TIME: 13:25DIRECTION OF  
PHOTOGRAPH:  
NORTH - NEWEATHER  
CONDITIONS:  
PARTLY SUNNY  
~ 70 °FPHOTOGRAPHED BY:  
D. SULLIVANSAMPLE ID  
(if applicable):  
S3

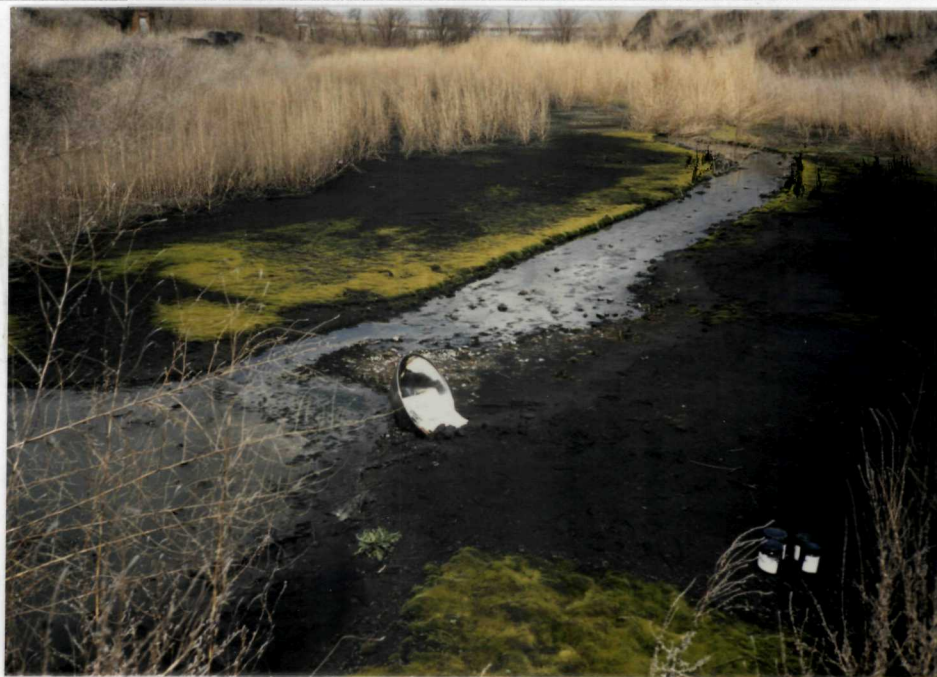
DESCRIPTION: PERSPECTIVE OF SOIL SAMPLE S3. FLY ASH  
PILE IS LOCATED ON RIGHT SIDE OF PHOTO.

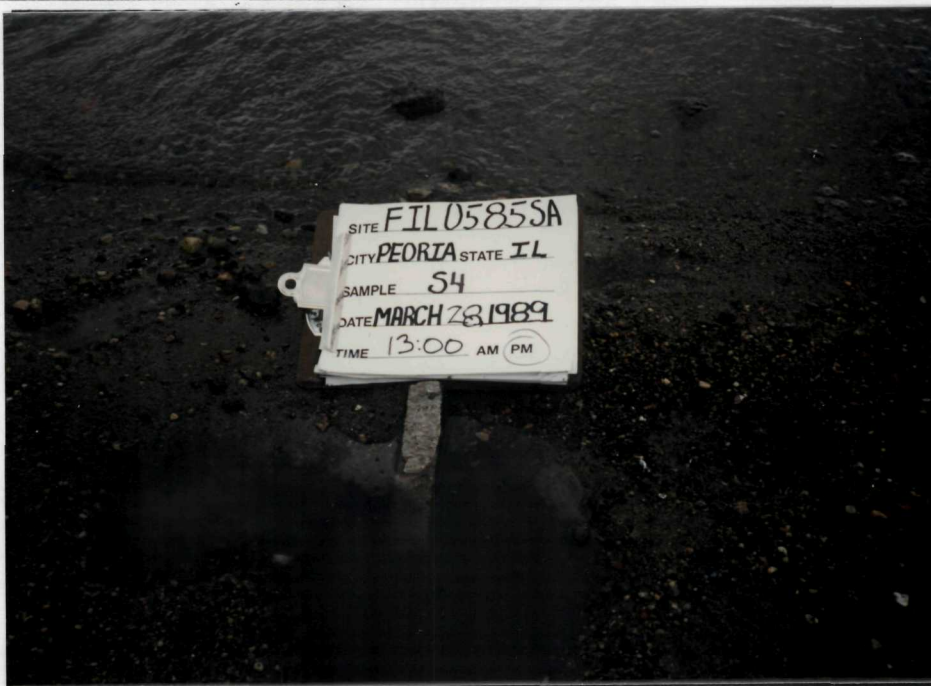
DESCRIPTION: CLOSE - UP OF SEDIMENT SAMPLE S4.DATE: 3-28-89TIME: 13:00DIRECTION OF  
PHOTOGRAPH:  
NORTHEASTWEATHER  
CONDITIONS:  
PARTLY CLOUDY~ 70°FPHOTOGRAPHED BY:  
D. SULLIVANSAMPLE ID  
(if applicable):  
S4

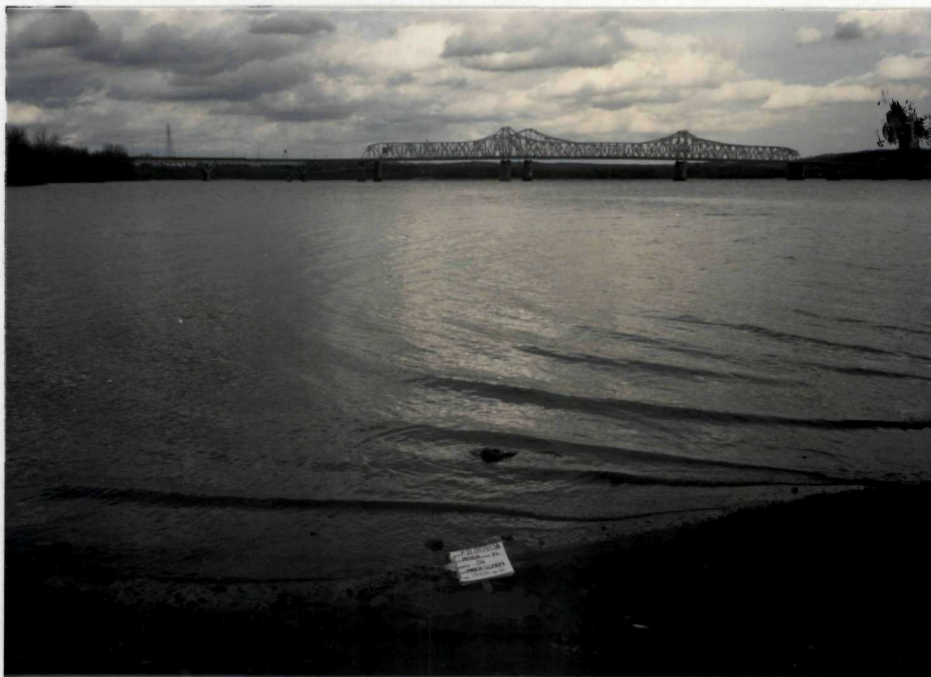
DESCRIPTION: PERSPECTIVE OF SEDIMENT SAMPLE S4. THE  
McCLUGAGE BRIDGE IS SHOWN IN BACKGROUND.

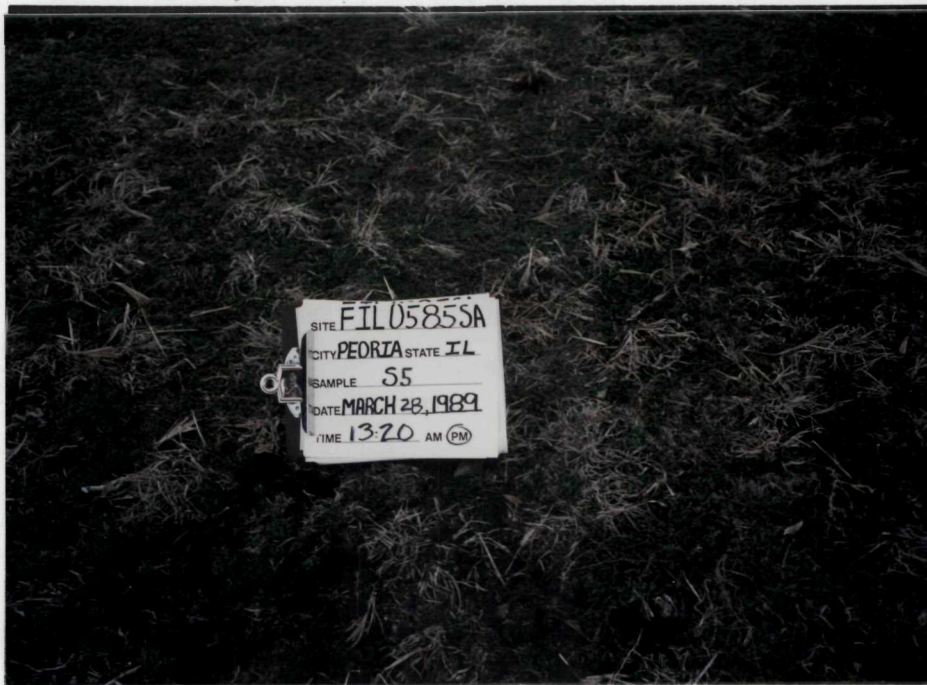
DESCRIPTION: CLOSE-UP OF SOIL SAMPLE S5, COLLECTED AS  
A POTENTIAL BACKGROUND SOIL SAMPLE.DATE: 3-28-89TIME: 13:20DIRECTION OF  
PHOTOGRAPH:  
NORTHWEATHER  
CONDITIONS:  
PARTLY CLOUDY~ 70°FPHOTOGRAPHED BY:  
D. SULLIVANSAMPLE ID  
(if applicable):  
S5

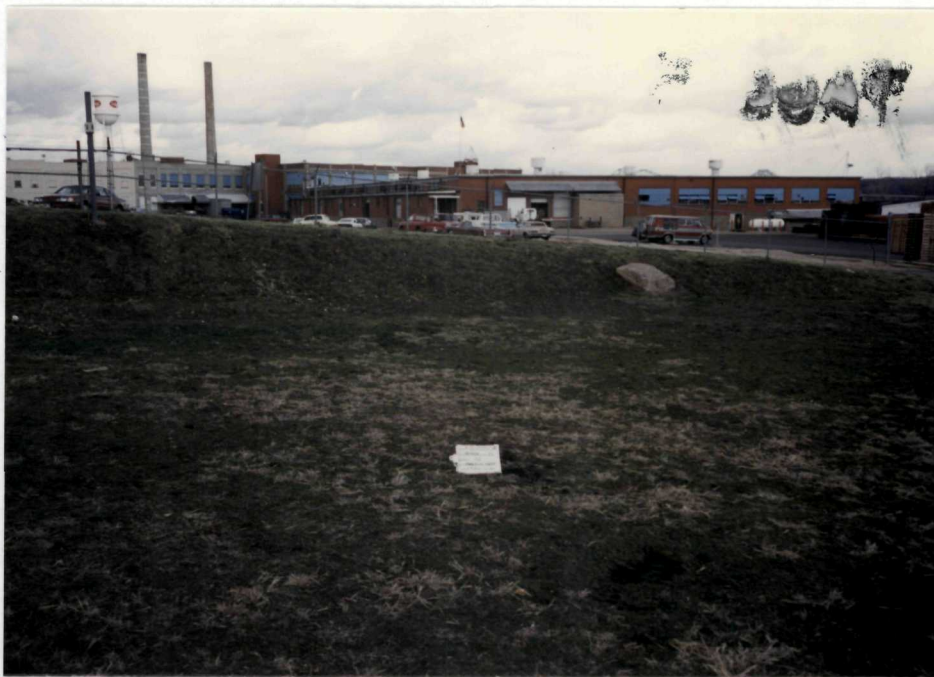
DESCRIPTION: PERSPECTIVE OF SOIL SAMPLE S5.

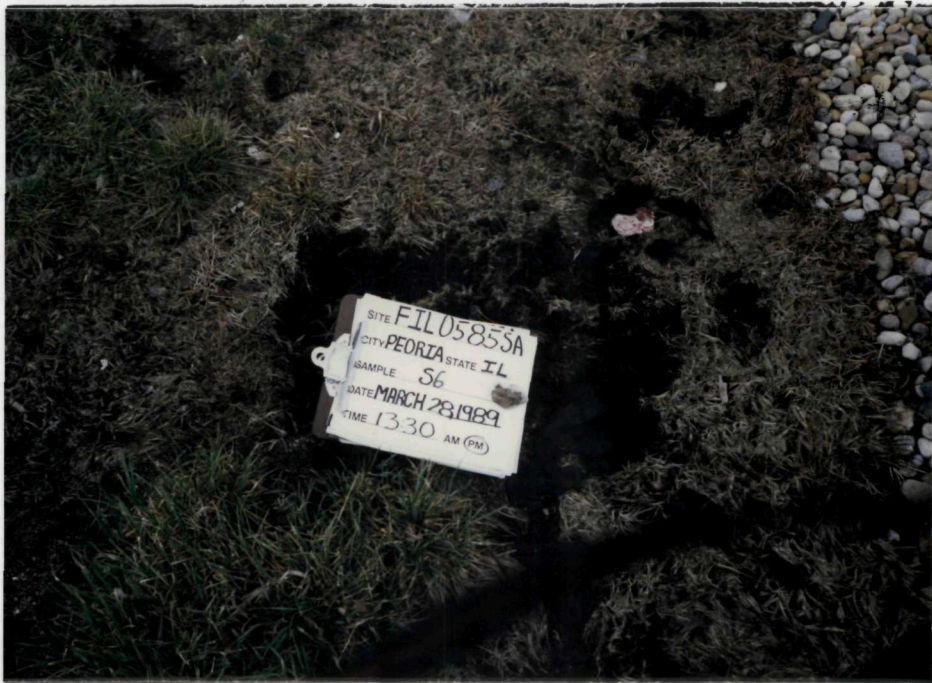
DESCRIPTION: CLOSE-UP OF SOIL SAMPLE S6.DATE: 3-28-89TIME: 13:30DIRECTION OF  
PHOTOGRAPH:  
NORTHWEATHER  
CONDITIONS:  
PARTLY CLOUDY~ 70 °FPHOTOGRAPHED BY:  
D. SULLIVANSAMPLE ID  
(if applicable):  
S6

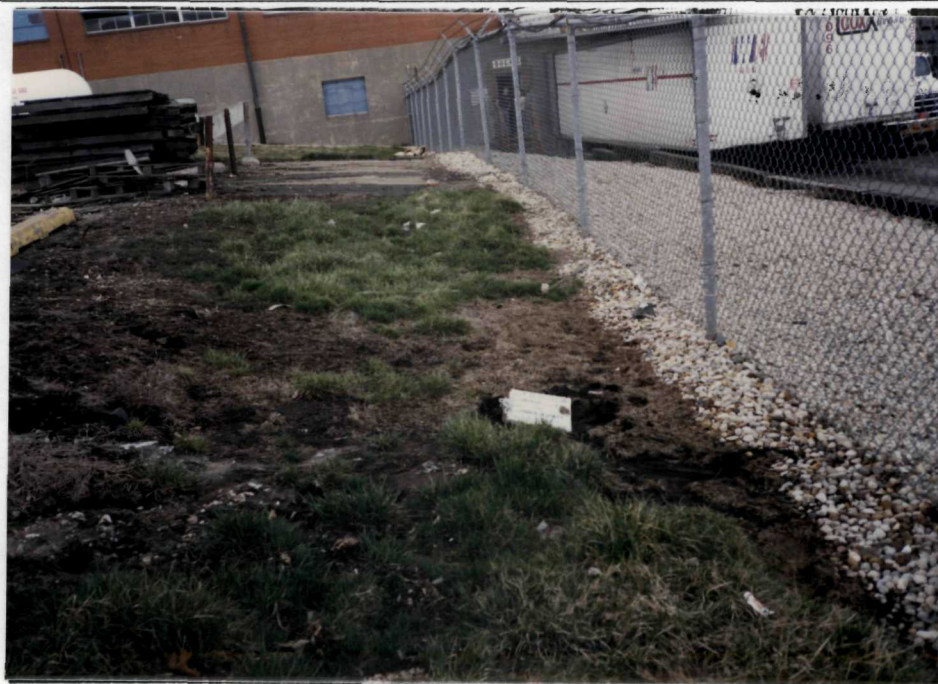
DESCRIPTION: PERSPECTIVE OF SOIL SAMPLE S6. DRUMS  
ARE STORED TO THE LEFT OF AREA SHOWN IN PHOTO.

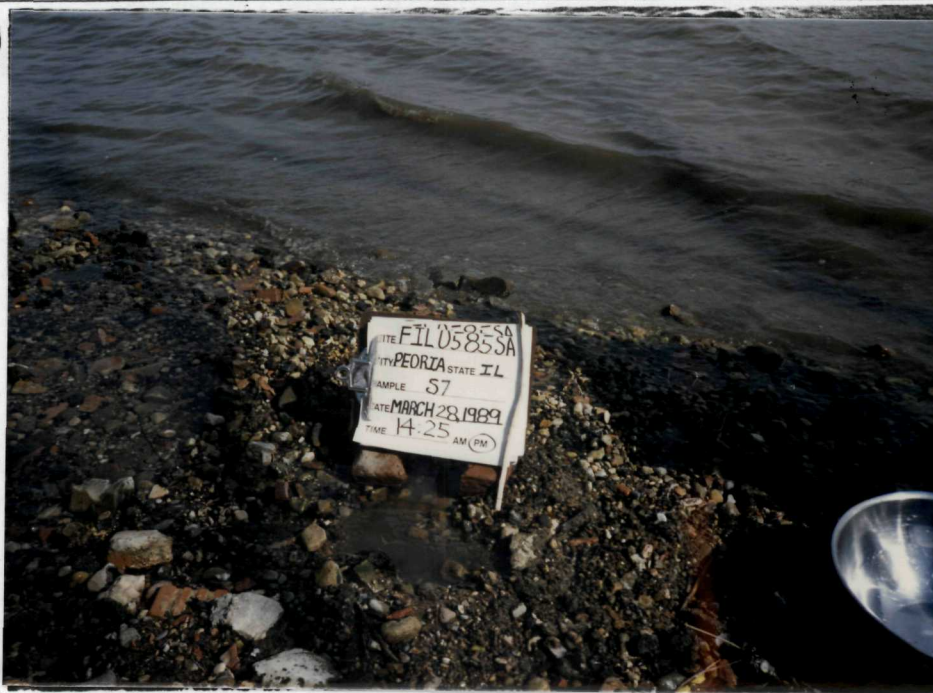
DESCRIPTION: CLOSE-UP OF SEDIMENT SAMPLE S7.DATE: 3-28-89TIME: 14:25DIRECTION OF  
PHOTOGRAPH:EAST

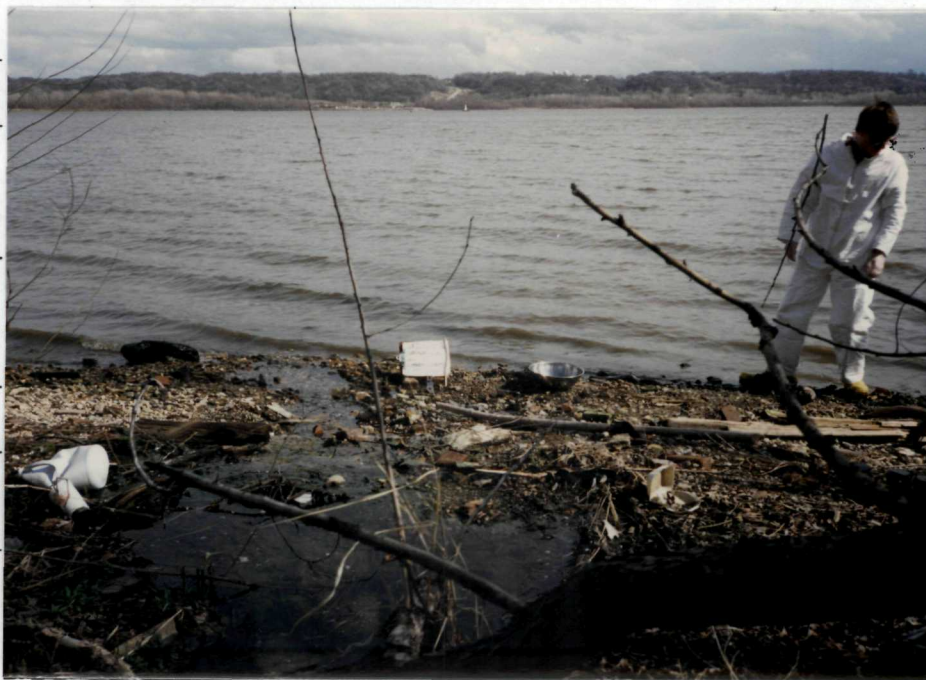
DESCRIPTION: PERSPECTIVE OF SEDIMENT SAMPLE S7.

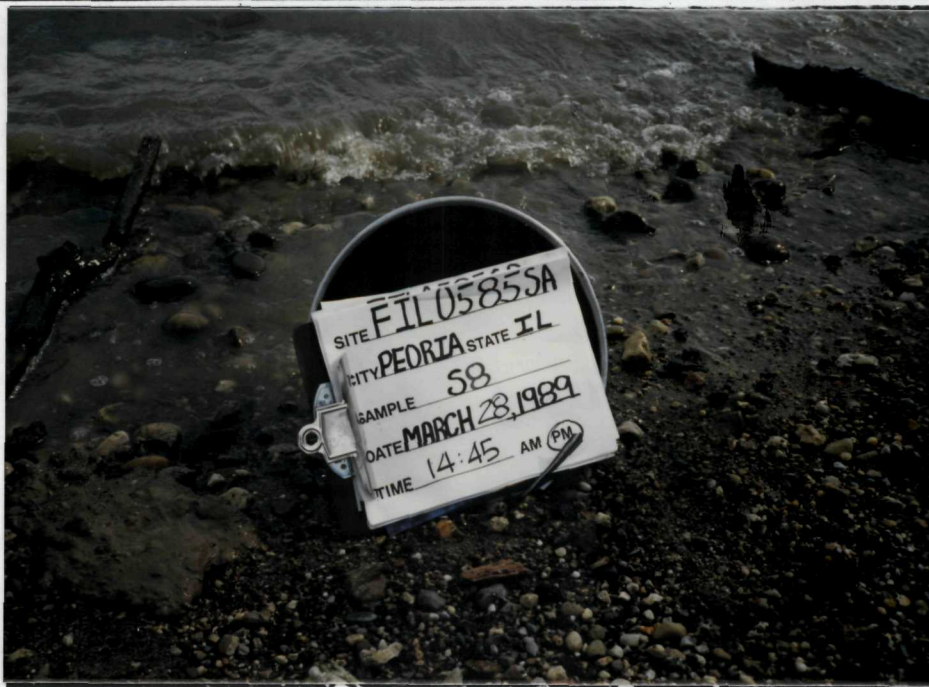
DESCRIPTION: CLOSE-UP OF SEDIMENT SAMPLE S8.DATE: 3-28-89TIME: 14:45DIRECTION OF  
PHOTOGRAPH:  
NORTHEASTWEATHER  
CONDITIONS:  
PARTLY CLOUDY~ 70 °FPHOTOGRAPHED BY:  
D. SULLIVANSAMPLE ID  
(if applicable):  
S8

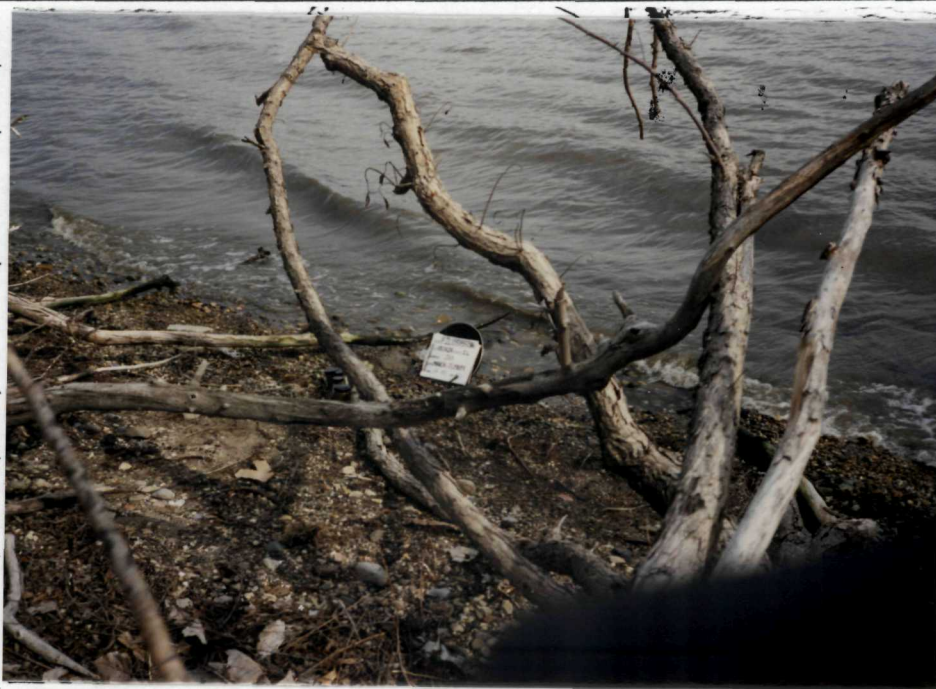
DESCRIPTION: PERSPECTIVE OF SEDIMENT SAMPLE S8.

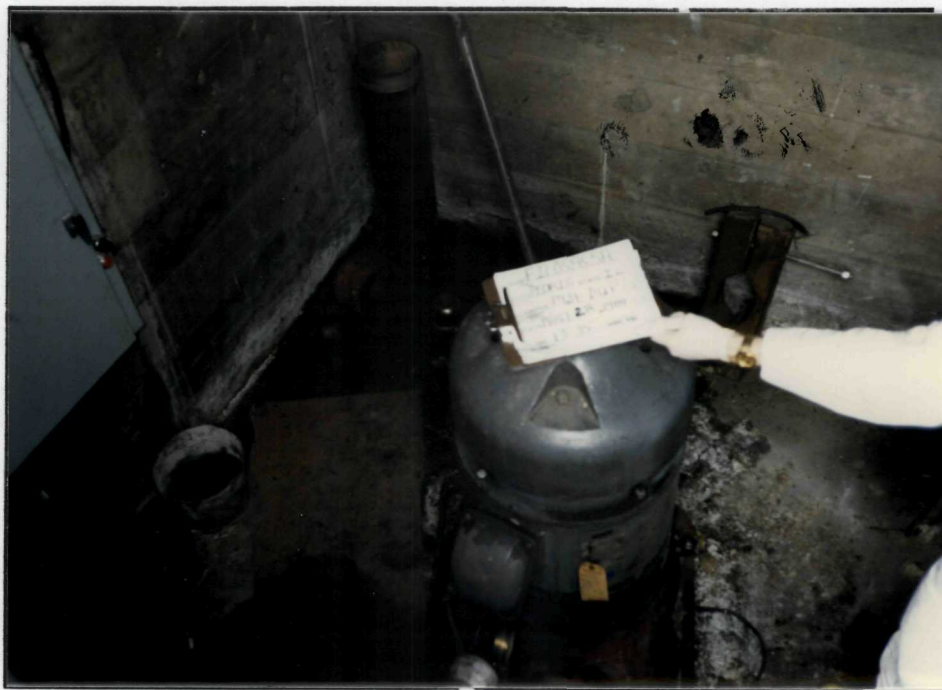
CLOSE-UP OF PRODUCTION WELL SAMPLE PW1.

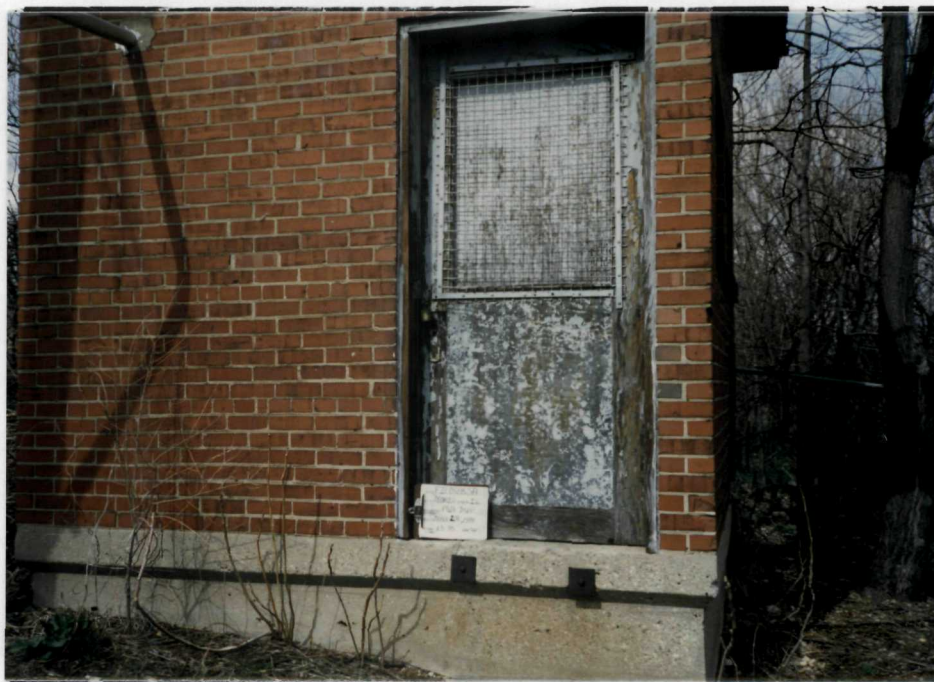
DATE: 3-28-89TIME: 13:35DIRECTION OF  
PHOTOGRAPH:  
NORTHWEATHER  
CONDITIONS:  
PARTLY SUNNY~ 70°FPHOTOGRAPHED BY:  
D. SULLIVANSAMPLE ID  
(if applicable):  
PW1DESCRIPTION: PERSPECTIVE OF PRODUCTION WELL SAMPLE PW1.

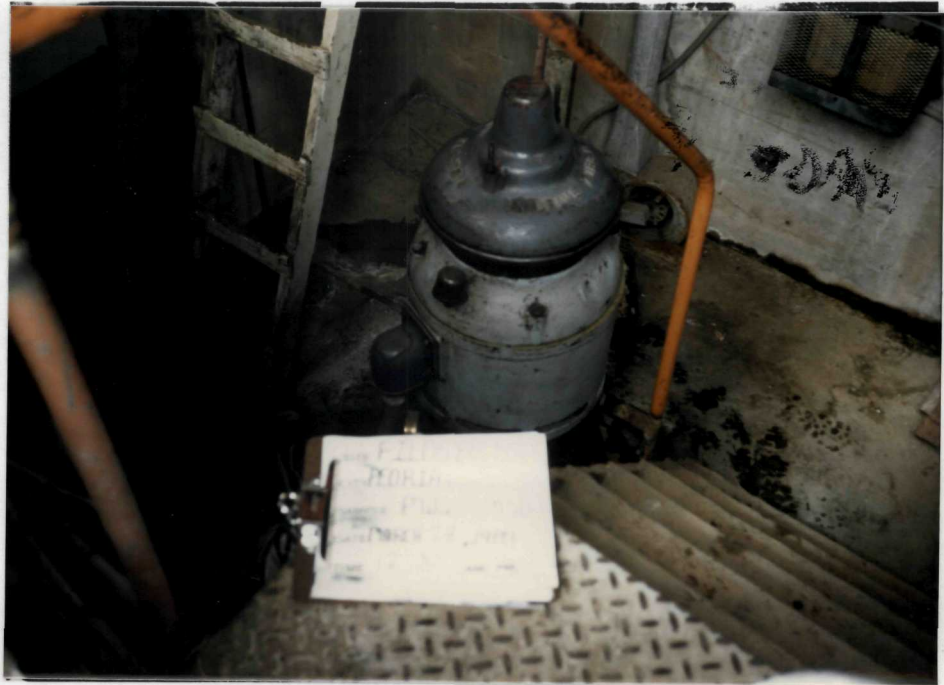
DESCRIPTION: CLOSE-UP OF PRODUCTION WELL SAMPLE PW2.

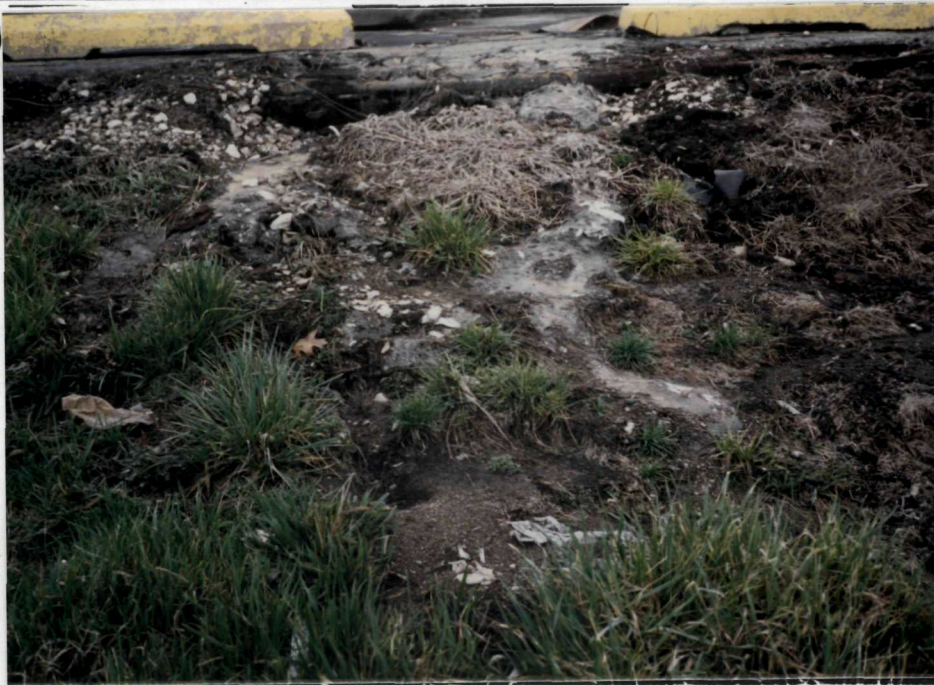
SOME STAINED GROUND OBSERVED WHERE BARRELS ARE STORED.  
DIKE OBSERVED NEAR ILLINOIS RIVER, BUT HAS NOT PREVENTED FLOOD WATER FROM ENTERING THE SITE.

DESCRIPTION: AREA OF STAINED SOIL NEAR DRUM STORAGE. SOIL  
SAMPLE S6 WAS TAKEN FROM THIS AREA.DATE: 3-28-89

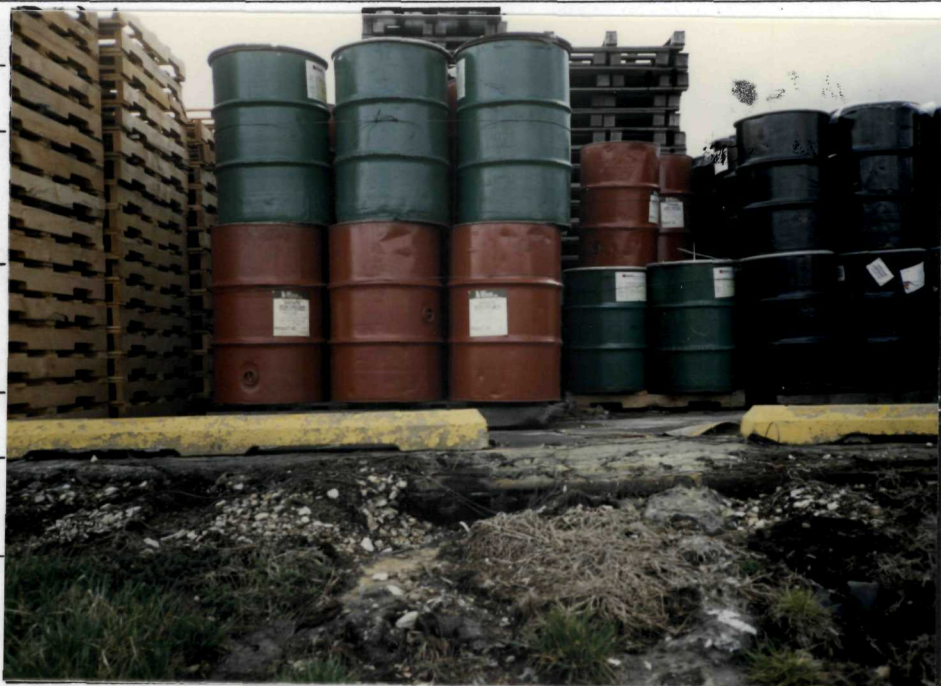
DESCRIPTION: DRUM STORAGE AREA. NOTE STAINED SOIL  
AT BOTTOM OF PHOTO. SOIL SAMPLE S6 WAS TAKEN  
FROM THIS AREA.

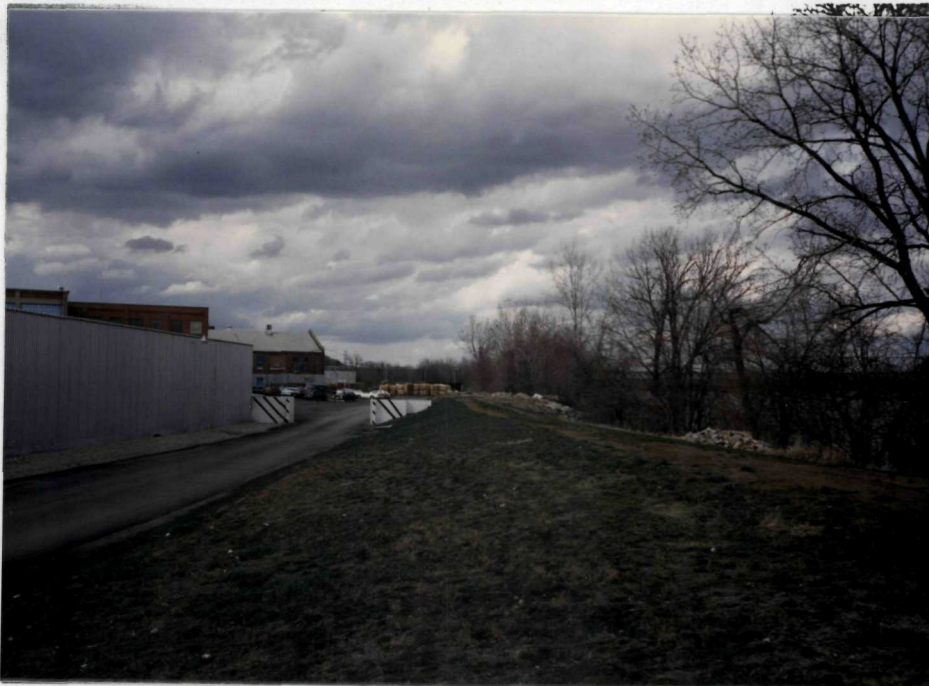
A dike, which paralleled the Illinois River, was observed on Bemis Company property. The dike was east of, and approximately 6 feet above, the road that runs along the back of the Bemis Company facility.

DESCRIPTION: PERSPECTIVE OF DIKE SEPARATING BEMIS'  
PROPERTY FROM ILLINOIS RIVER.DATE: 3-28-89

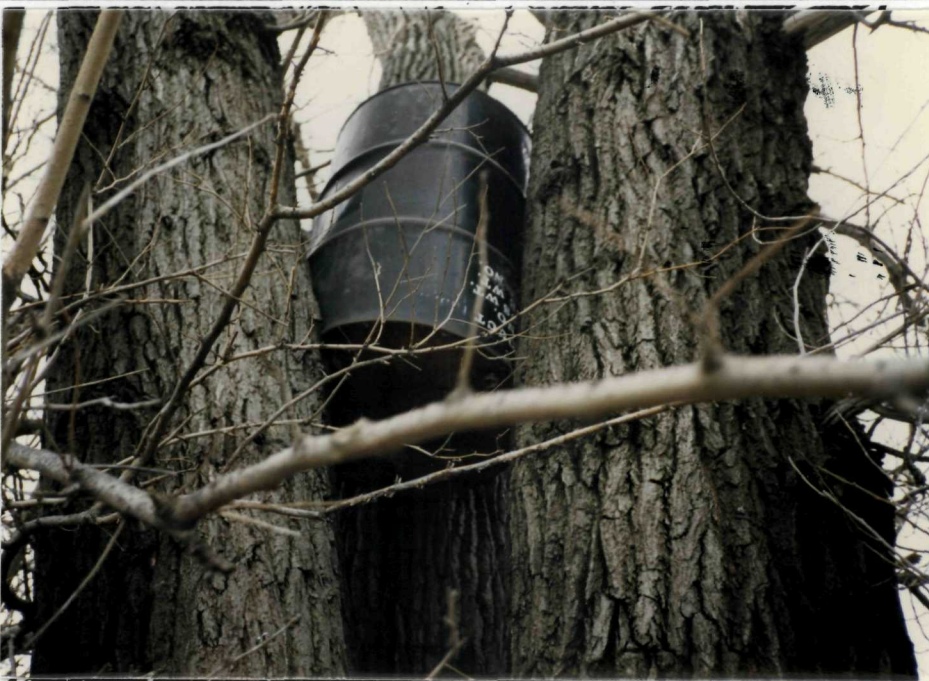
Two barrels were observed on Bemis Company property between the dike and the river. One was near the south fence and was labeled "Shell-GP Cling Oil"; the other was in a tree approximately 100 yards north of the southern site boundary. No readable markings were on the second barrel.

DESCRIPTION: BARREL FOUND IN TREE LOCATED ON BEMIS'  
PROPERTY BETWEEN THE DIKE AND ILLINOIS RIVER.

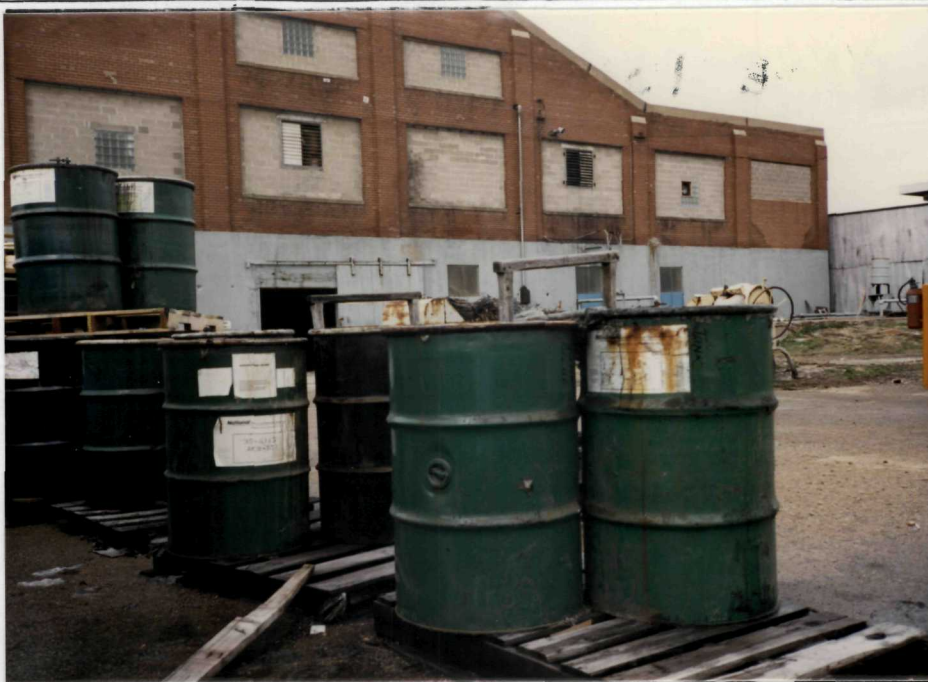
The reconnaissance inspection commenced at the southern border of the Ivex property on the Illinois River side. Behind the southernmost building on the Ivex property approximately 10 to 15 barrels were observed. The barrels were labeled "National Starch and Chemical-Resyn 33-4038." The barrels were resting on wooden pallets and the ground surface surrounding the barrels was concrete-paved. The barrels had stains on the sides but no active leakage was observed.

DESCRIPTION: BARRELS OBSERVED ON SOUTHEAST SECTION OF  
IVE X PROPERTY,

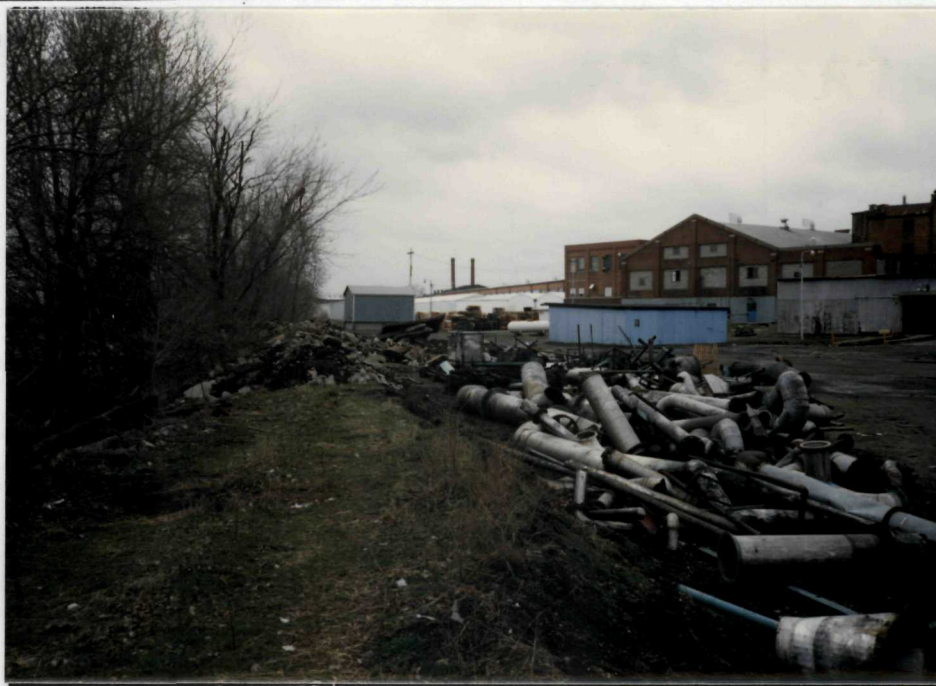
Along the southern side of the fence, large piles of metal debris were observed. A pile of metal debris was also observed paralleling the Illinois River on the east border of the facility from the three-sided garage to the fence.

DESCRIPTION: PERSPECTIVE OF IVEX PROPERTY SHOWING  
DEBRIS ALONG THE EASTERN EDGE OF THE FACILITY.

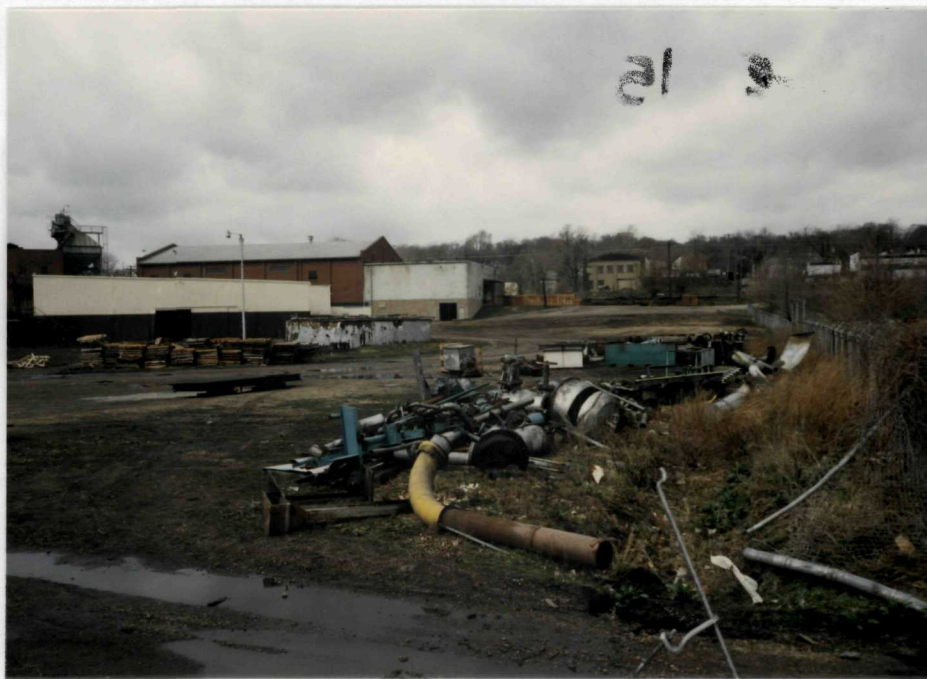
DESCRIPTION: PERSPECTIVE OF IVEX PROPERTY SHOWING  
VARIOUS DEBRIS. NOTE OIL TANK IN BACKGROUND.

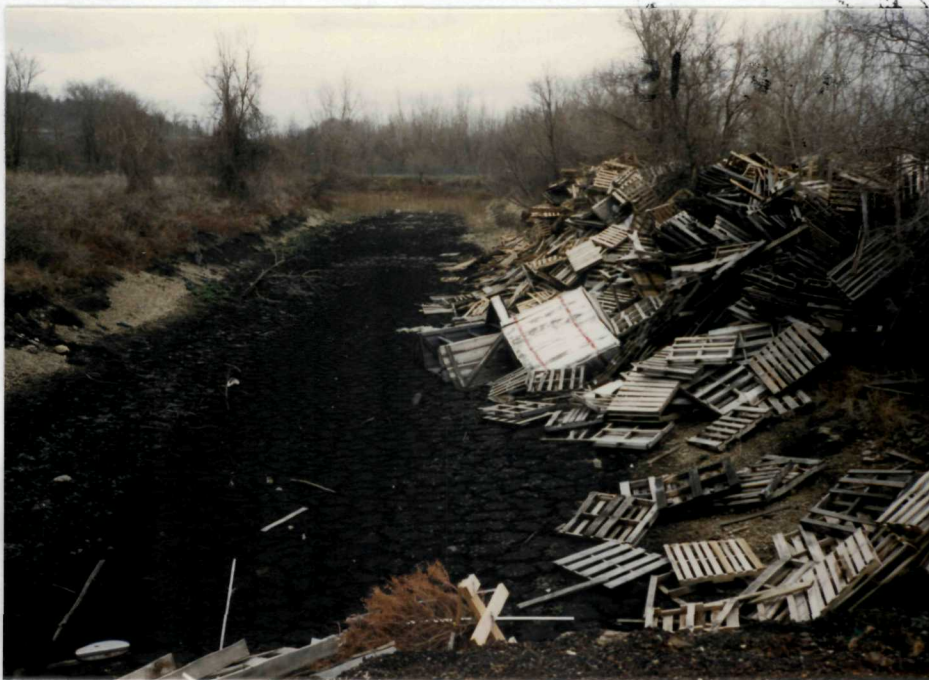
A gravel road connects the active facility to the fly ash/cooling canal area on the northern portion of the site. The road separates the cooling canal from the river. The cooling canal is dry and no longer used. The western portion of the cooling canal is known as section 1, and the eastern portion is known as section 2. Large piles of wooden platforms were observed in the southeast corner of section 2 of the cooling canal. Section 1 appeared to be free of debris (see Figure 3-1). Near the north border of the site, a rusted barrel was observed in some tangled underbrush between the gravel road and the river.

DESCRIPTION: PERSPECTIVE OF COOLING CANAL FROM THE  
SOUTH.DATE: 3-28-89TIME: 10:50DIRECTION OF  
PHOTOGRAPH:  
SOUTH - SWWEATHER  
CONDITIONS:  
PARTLY CLOUDYPHOTOGRAPHED BY:  
D. SULLIVANSAMPLE ID  
(if applicable):

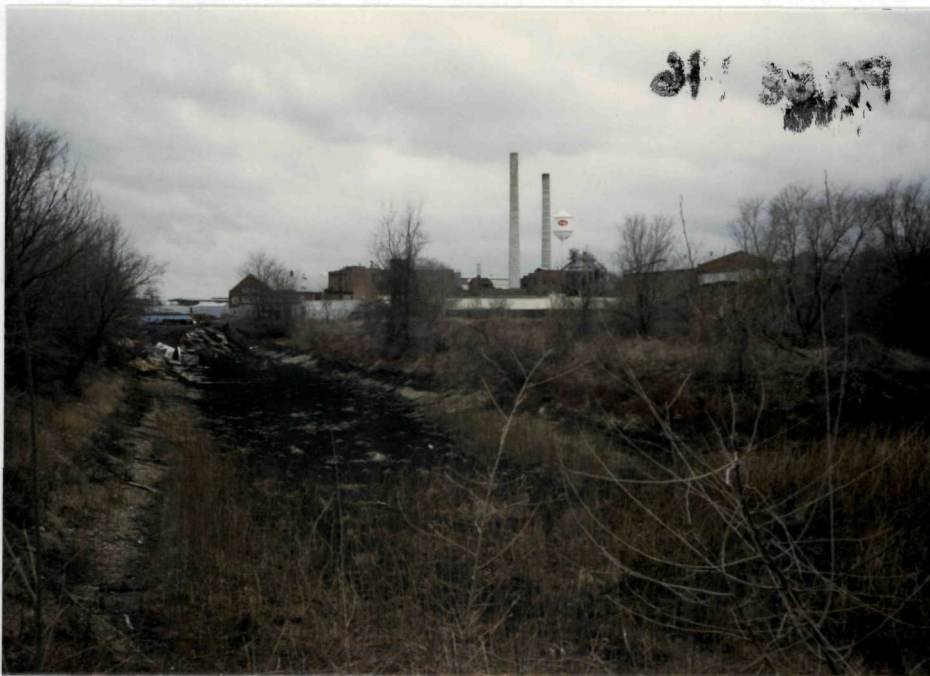
DESCRIPTION: PERSPECTIVE OF COOLING CANAL FROM THE  
NORTH.
